# Manhole Inspection Summary

Manhole # S17I\_\_032MH

Insp Date: **2/27/08 9:06 AM**

**Location** Address: **101 lipps In**

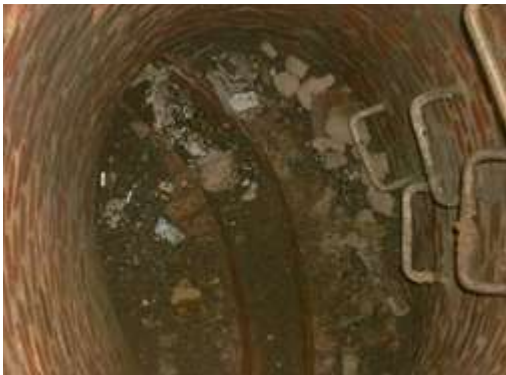
Defect 1

Condition: ☐ Sound ☐ Cracked ☐ Root Intrusion ☐ Deteriorated ☐ Leaks ☒ **Debris**

debris on the bench

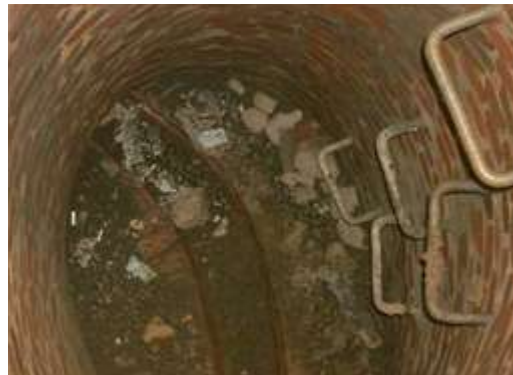
Defect 2

Condition: ☐ Sound ☐ Cracked ☐ Root Intrusion ☐ Deteriorated ☐ Leaks ☒ **Debris**

debris in the channel

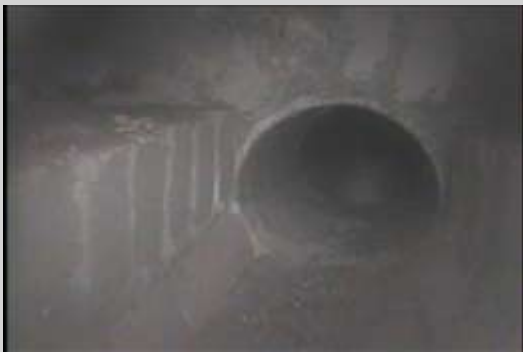
12 O'Clock Outflow

Pipe Height: **8.4** (in.) Rod and Bar (Angled)  
Pipe Material: **Clay** ☐ Pipe Lined  
Invert Depth: **13.00** (ft.) Flow Characteristics: **None**  
Deposits: ☒ None ☐ Mud ☐ Sludge ☐ Debris ☐ Grease  
Silt Depth: **0** (in.) Deposits Extent:  
Infiltration: **None** Pipe Seal Cond: **Sound**

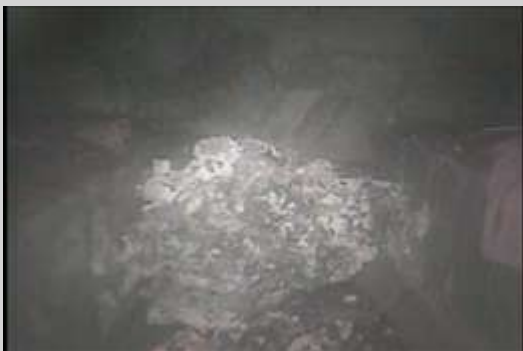
5 O'Clock Inflow

pipe is totally blocked by debris

Pipe Height: **6** (in.) Rod and Bar (Angled)  
Pipe Material: **Clay** ☐ Pipe Lined  
Invert Depth: **12.86** (ft.) Flow Characteristics: **None**  
Deposits: ☐ None ☐ Mud ☐ Sludge ☐ Debris ☒ Grease  
Silt Depth: **6** (in.) Deposits Extent: **Heavy**  
Infiltration: **None** Pipe Seal Cond: **Unknown**
